Double Lap Shear Testing of Coating Modified Ice Adhesion to Liquid Oxygen Feed Line Bracket, Space Shuttle External Tank

May 2006

Final report

Prepared for National Aeronautics and Space Administration

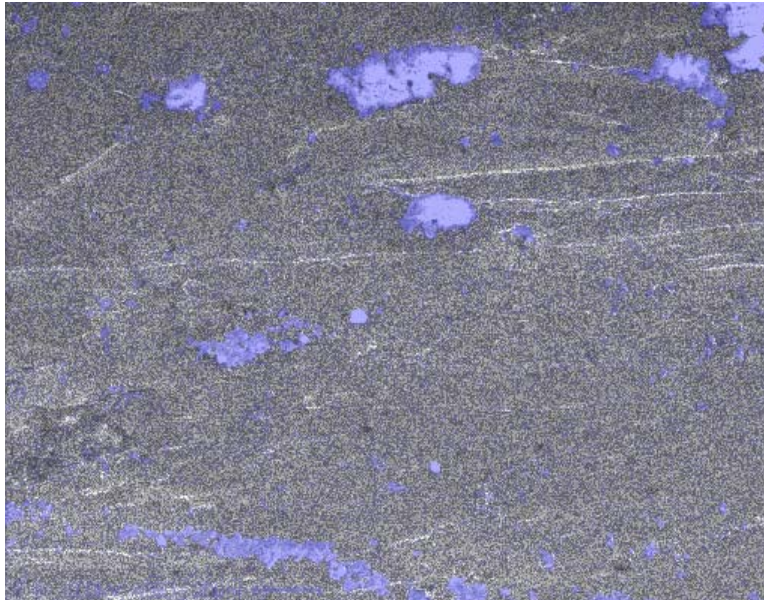
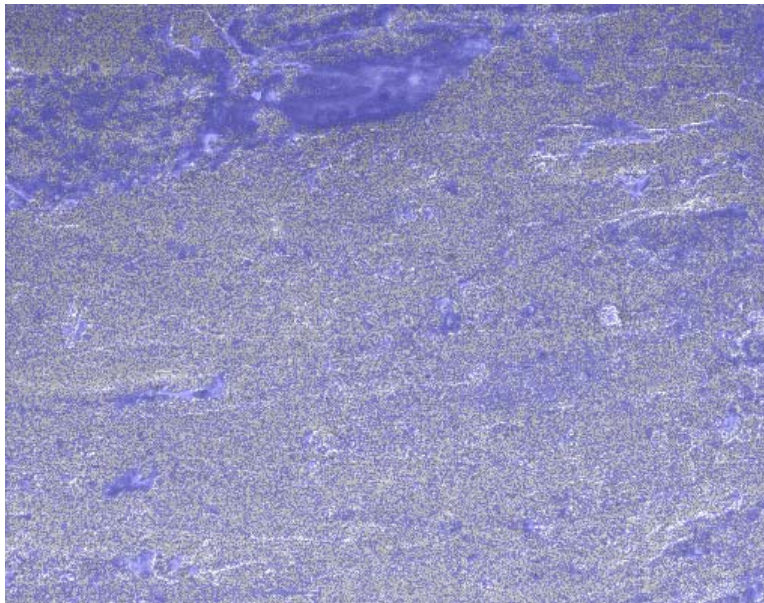
a. Thin coating of Rain-X-MP-55 after more than 2 days of curing,.

b. Re-analysis of the same coupon following abrasive wiping.

Scanning electron microscopy (SEM), coupled with an energy dispersive spectroscopy elemental map of fluorine, was used to visualize conditions on thinly RXM coated coupon surfaces. A test coupon was coated and cured for 2+ days prior to analysis, abrasive wiping, and re-analysis. The MP-55 was evenly dispersed throughout the coating on the surface of the non-wiped coupon, and abrasive wiping did not remove a significant portion of the Teflon from the surface. Measured MP-55 bead diameters fell below the wavelength of visible light, inferring that though the coating may appear to have been removed, it is still present. These SEM results verify the presence of MP-55 on the coupon surface following abrasion, and support those of the XPS and contact angle analyses.

Scanning electron microscopy (SEM) coupled with an energy dispersive spectroscopy (EDS) elemental map of fluorine was used to visualize conditions on Rain-X–MP-55 coated coupon surfaces. A test coupon was thinly coated and left to cure for more than 2 days prior to analysis, abrasive wiping, and re-analysis. Figure 49a shows evenly dispersed MP-55 throughout the coating of the non-wiped coupon with particle agglomerations present. The repeat SEM-EDS map in t Figure 49b, obtained after abrasive wiping of the coupon, once again shows the MP-55 to be well dispersed on the surface without significant agglomerations present. The abrasive wipe did not remove Teflon from the surface of the sample. The diameters of the MP-55 beads, measured by the SEM, fall below the wavelength of visible
